Manhole Inspection Summary

Manhole # S17M__002MH

Location Address: **2502 LEHMAN ST**

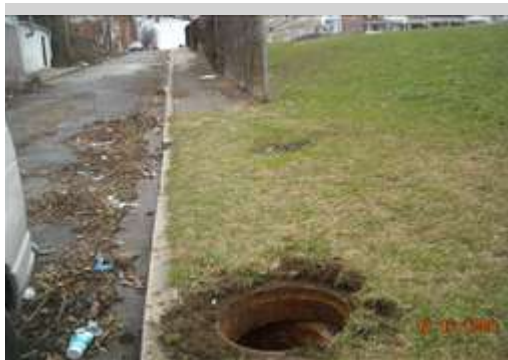
Location View

Comments **CORBEL OFFSET OF 10 INCHES. LOCATED IN GRASS AREA WITH T-PROBE. FORCED LID OPEENING WITH 16LB MAUL AND SPRAY LUBRICANT. NO SIGNIFICANT DAMAGE TO COVER FROM OPENNING.**
